REDIES

Wire-Drawing Dies

The european wire die maker

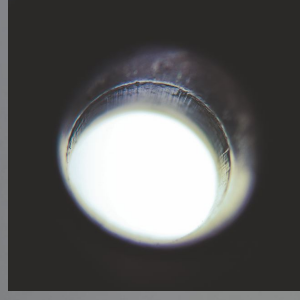
### BEFORE

#### palpable problems:

- drawing forces increase
- incomplete lubrication
- wire product not round
- unsatisfactory wire surface
- wire diameter too big

Material to be removed →

#### visible problems:

- ring-shaped indentation
- polish damaged
- holes

entry

50°

### AFTER

- geometry and proportions remain
  - technically a new die\*
- back relief enhances performance
  - repairing saves resources
- ...and two thirds of your money, on average

bearing

back relief

12°

exit

40°

\*quality depends on the blank. Crystal misalignment, for example, cannot be corrected for.
